Subject: Release Requirements, Perpetual Storage, Inc., Perpetual Storage Vault,
S/035/013, Salt Lake County, Utah

Inspection Report

Mine Name: Perpetual Storage Vault
Operator Name: Perpetual Storage, Inc.

Permit number: S/035/013
Inspection Date: December 22, 2005
Time: 1:10-1:30 PM

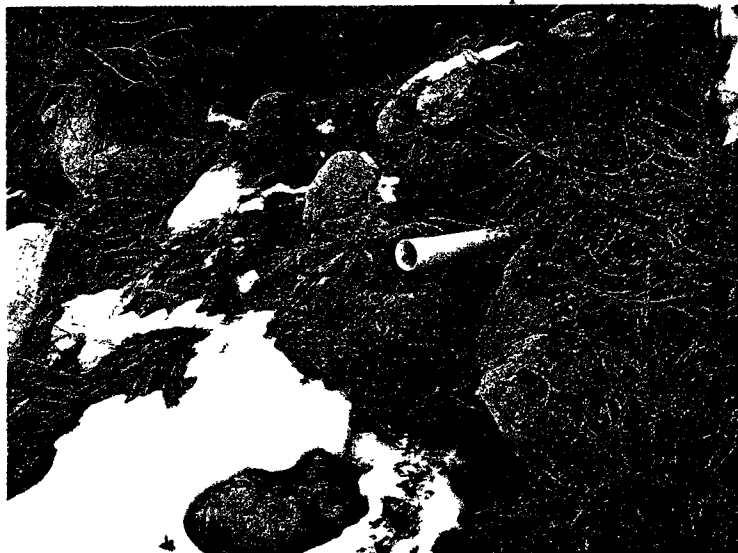
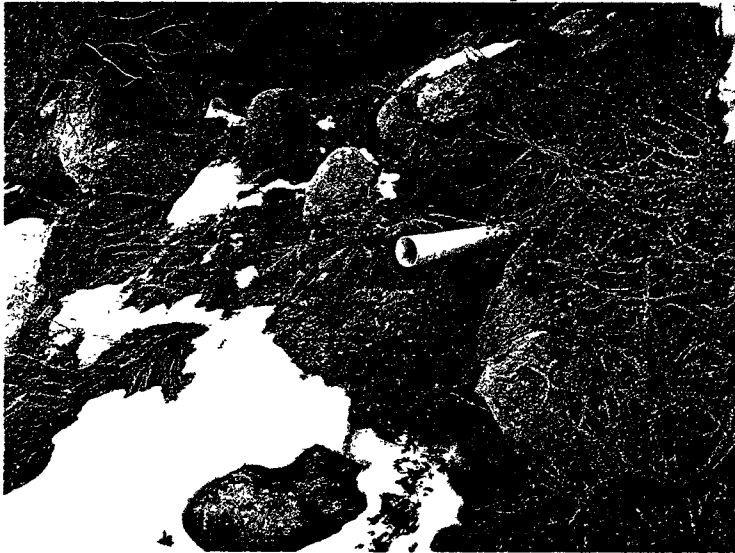
A PVC pipe extends out from where the operator drilled (Photo 1). There was a small stream of water coming from this pipe during the inspection. Mr. Willden thought this pipe extended about 50 feet into colluvium but not into the bedrock.

Photo 1. PVC pipe extending from where the operator drilled horizontally into the mountain.

Based on information you provided, it appears the old access road has not been used since 1975 when the Act was passed. Therefore, the Division will not consider this disturbance subject to the requirements of the Act. The horizontal hole was drilled more recently, and, unless there is a reason for keeping it to facilitate a postmining land use, it needs to be plugged.

Portions of the PVC pipe within three feet of the surface should be removed, and the remaining pipe should be plugged with concrete then covered over with soil. Alternatively, the pipe could be removed completely and the void filled with earth materials.

Prior to release, I suggest that the drill hole be plugged.

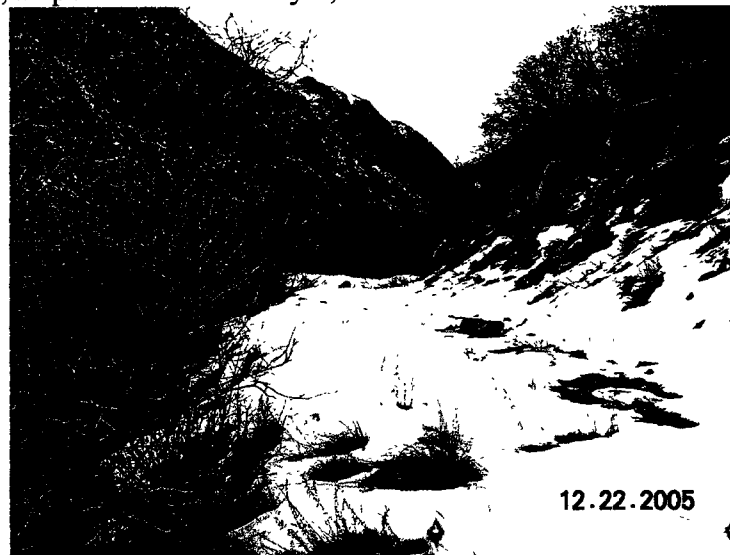
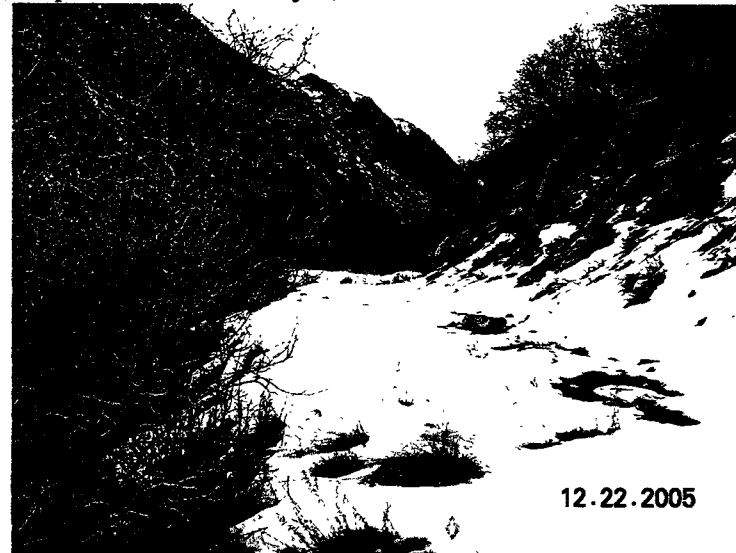
The original access road is shown in Photo 3. This road was not paved and had no guard rail. Some vegetation has become established on this road, but the cover does not match surrounding areas.

The only remaining issues relating to reclamation are the old access road and the unplugged horizontal drill hole. The road has not been used since about 1975, so it is not regulated under the Mined Land Reclamation Act.

Photo 3. The original access road.

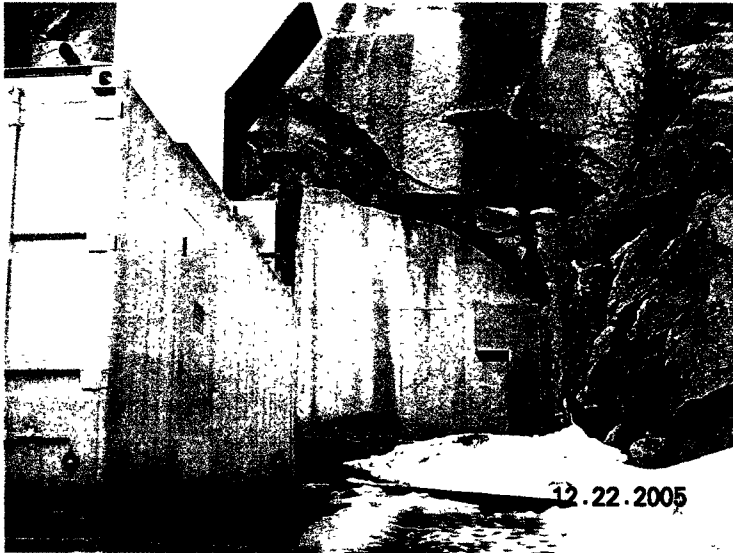
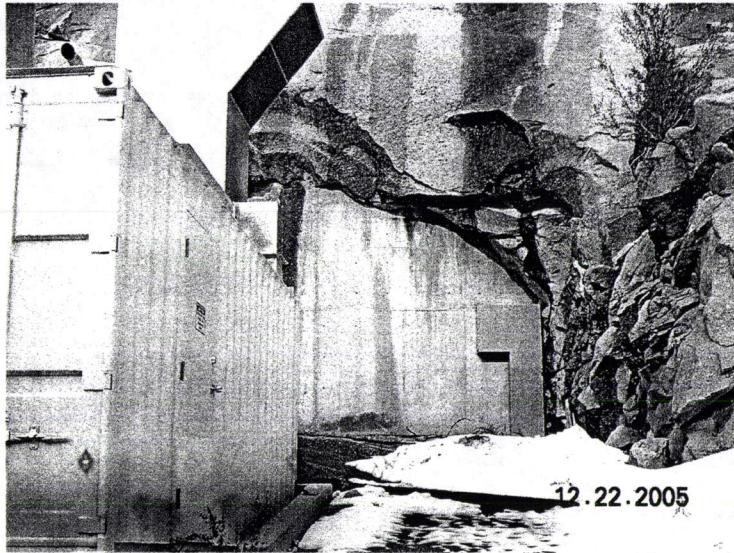
The entrance building and the wall at the tunnel entrance are shown in Photos 4 and 5.

Photo 5. Wall at the outside of the tunnel.

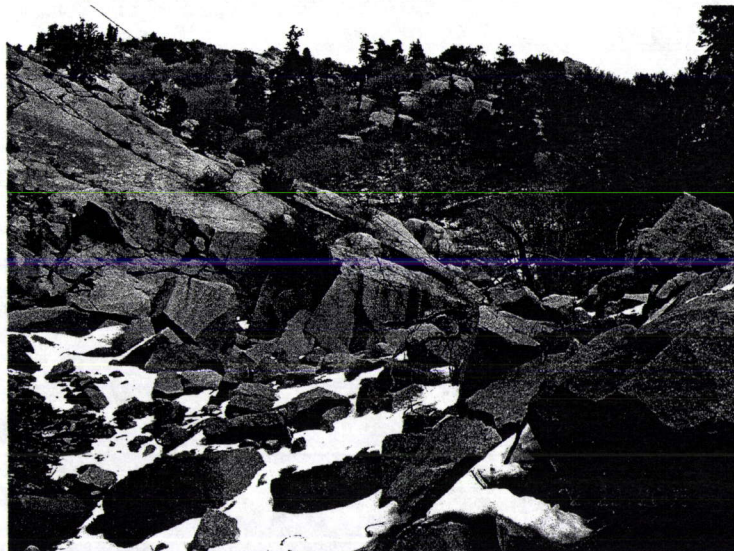
There is an ephemeral drainage that comes down from the mountain (Photo 7), goes along the edge of the disturbed area, then through a culvert under the access road where it joins the parking lot (Photo

Photo 6. Ephemeral drainage channel above the site.

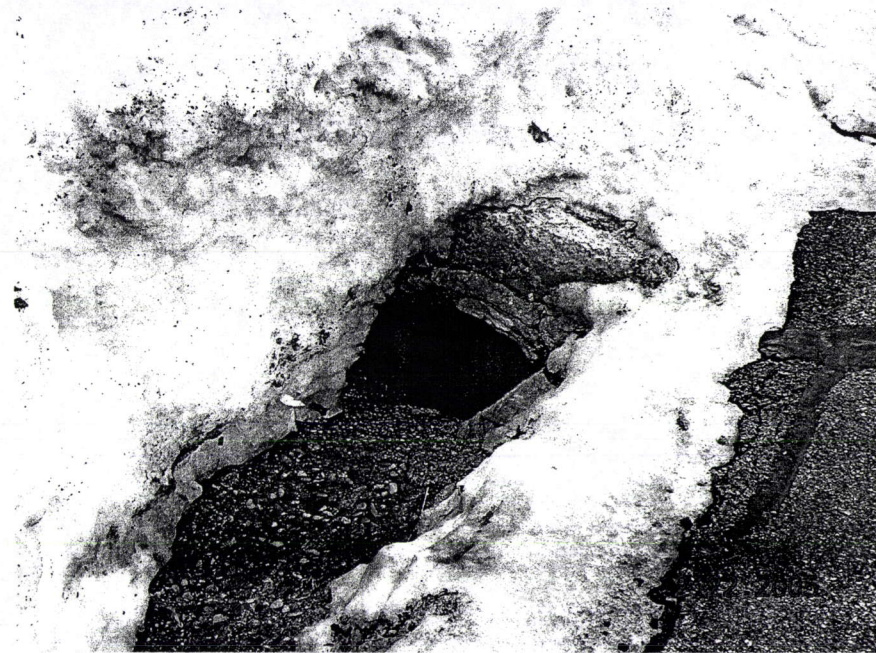
8). I remarked to Mr. Willden that I thought there would be times when this culvert would not be adequate to handle the flow, and he confirmed my suspicion. If the culvert was overtopped, water would simply flow across the road (some might go down the road) and on to the rock outslope on the south side.

Photo 7. Runoff from the channel shown in Photo 6 flow through this culvert (or over it).
